DECLARATION OF CONFORMITY DS/EN14351-1:2006

**Title: Impact testing Vitral Skyvision
Rooflights**

Certificate of Test Number: 14225

TEST REPORT NO 89/1/LB/2018

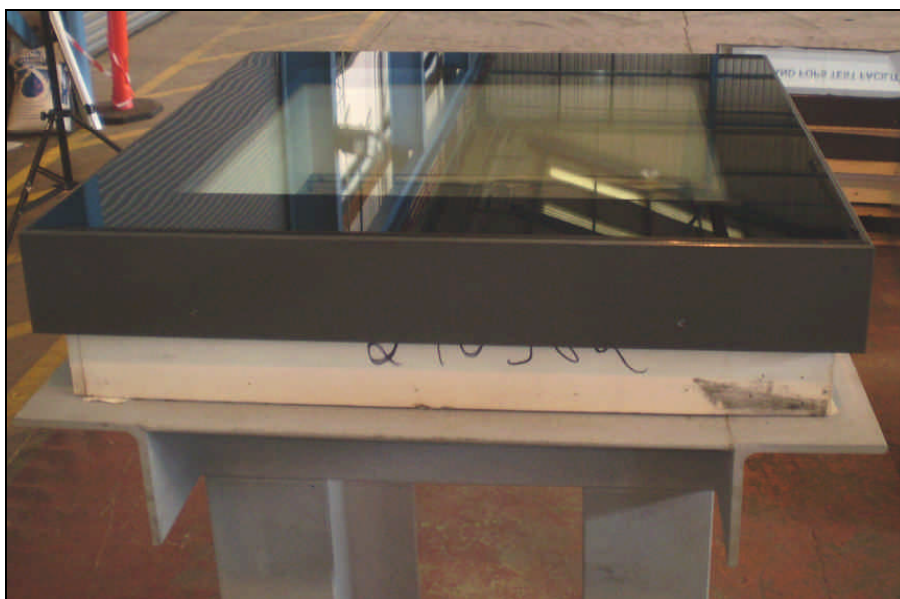
PHOTO 4120048

The sample had clear internal dimensions of 0.6 m by 0.6 m.

- 8 mm toughened outer
- 16 mm Argon filled cavity with TGI "warm edge" spacer
- 8.8 mm clear laminate inner

TEST SAMPLE

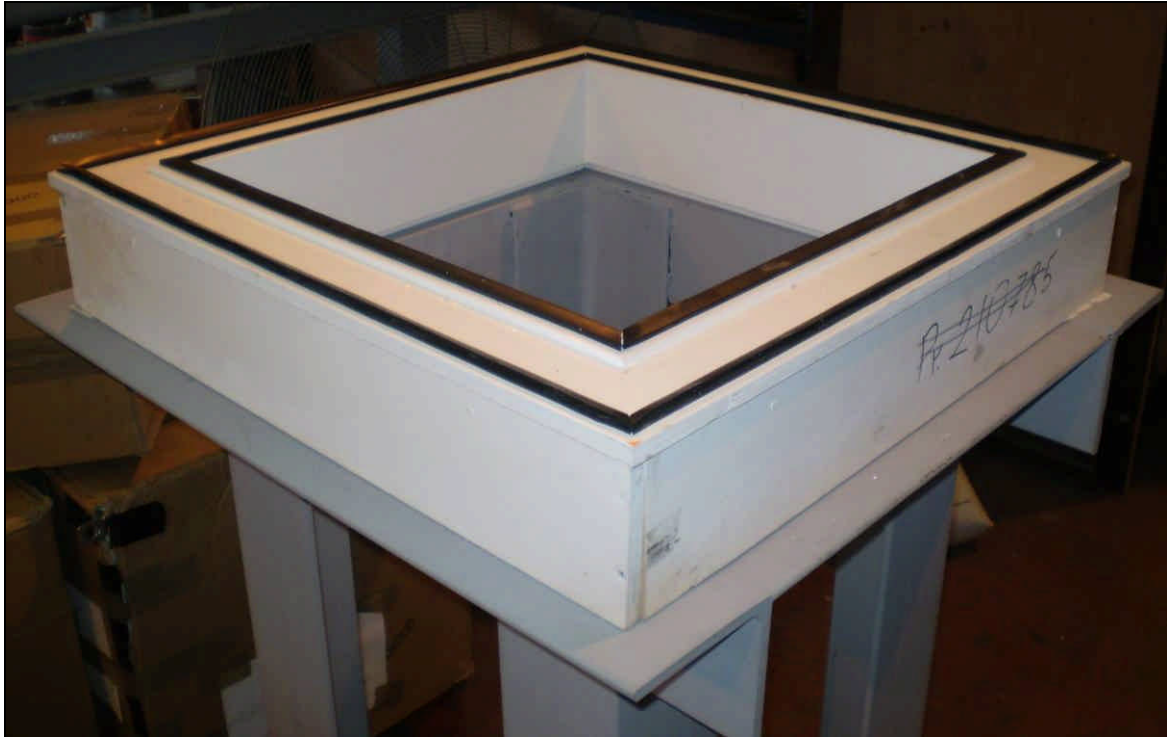
PHOTO 010001

All samples were mounted on a rigid steel frame bolted to the floor.

TEST SAMPLE FRAME

The test rig comprised a horizontal steel angle framework. The test samples timber frame was fixed onto the support frame and the glass and aluminium frame lifted onto the timber frame.

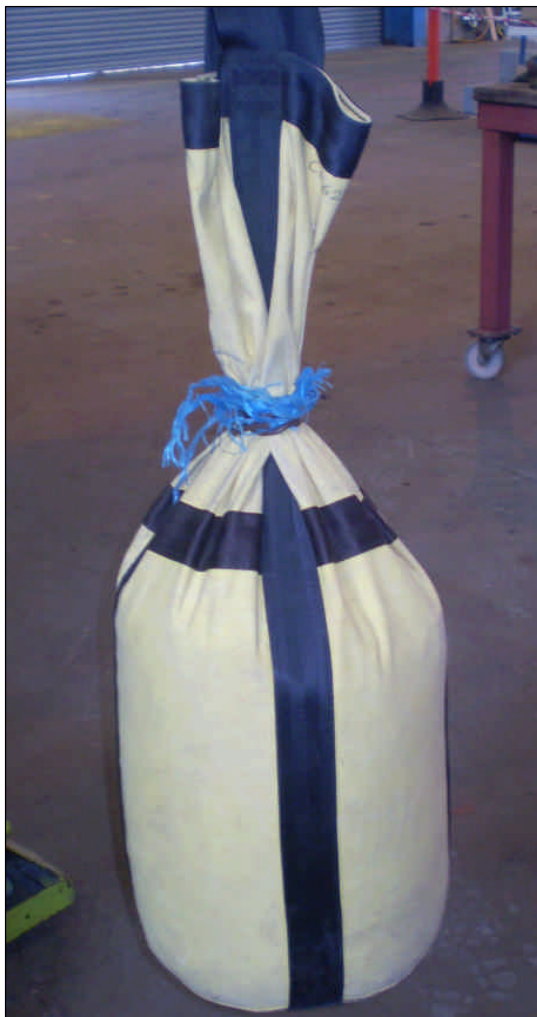
PHOTO SBIMPACTOR

The soft body impactor comprised a canvas spherical/conical bag 300 mm in diameter filled with sand with a total mass of approximately 45 kg suspended from a cord with a quick release mechanism.

SOFT BODY IMPACTOR

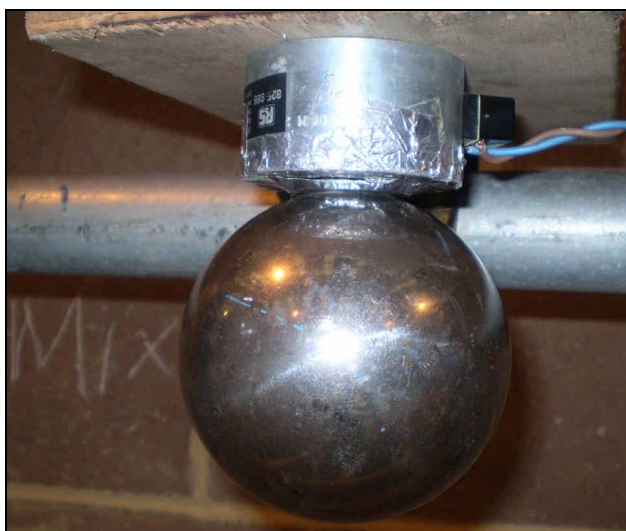
PHOTO HBIMPACTOR

The hard body impactor was a solid steel ball of 100 mm diameter and approximate mass of 4.1 kg. The impactor was held prior to dropping by an electromagnet.

HARD BODY IMPACTOR

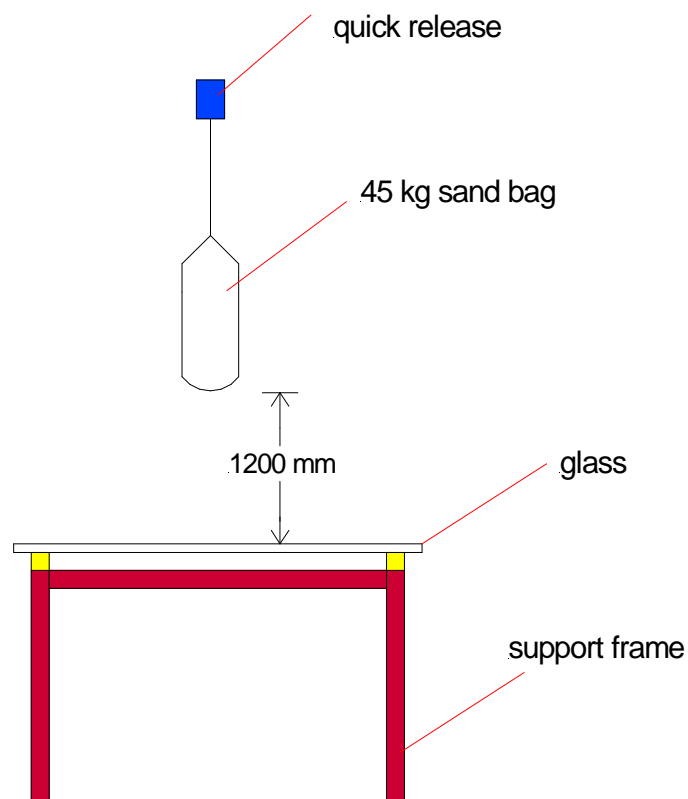
FIGURE 1

TEST RIG GENERAL ARRANGEMENT FOR SOFT BODY IMPACTOR

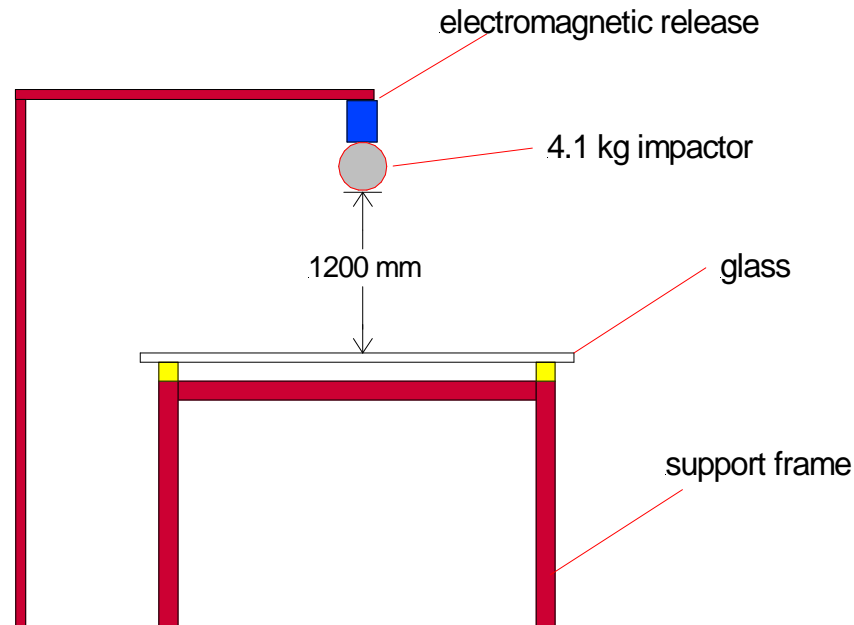
FIGURE 2

TEST RIG GENERAL ARRANGEMENT FOR HARD BODY IMPACTOR

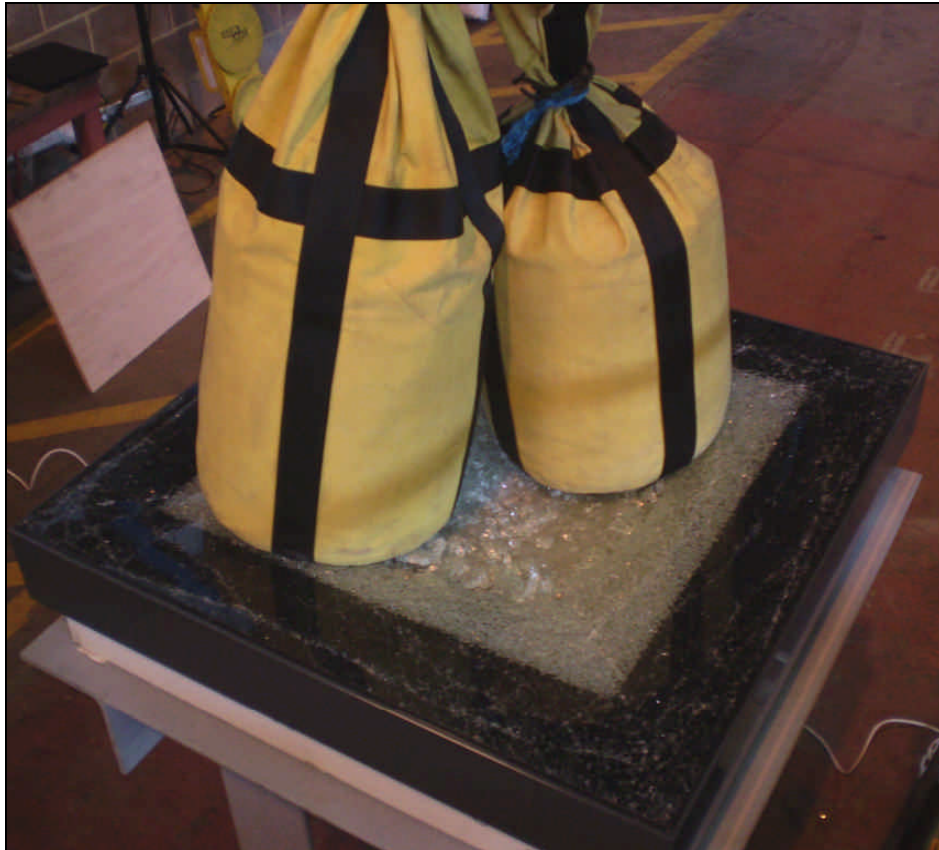
PHOTO 4120053

5.1.6 The 90 kg static load was held for 30 minutes.

5.1.7 Only very small glass fragments were observed on the floor after the test. They were less than 50 mm long and 50 g in weight.

SAMPLE 1 WITH 90 KG STATIC LOAD

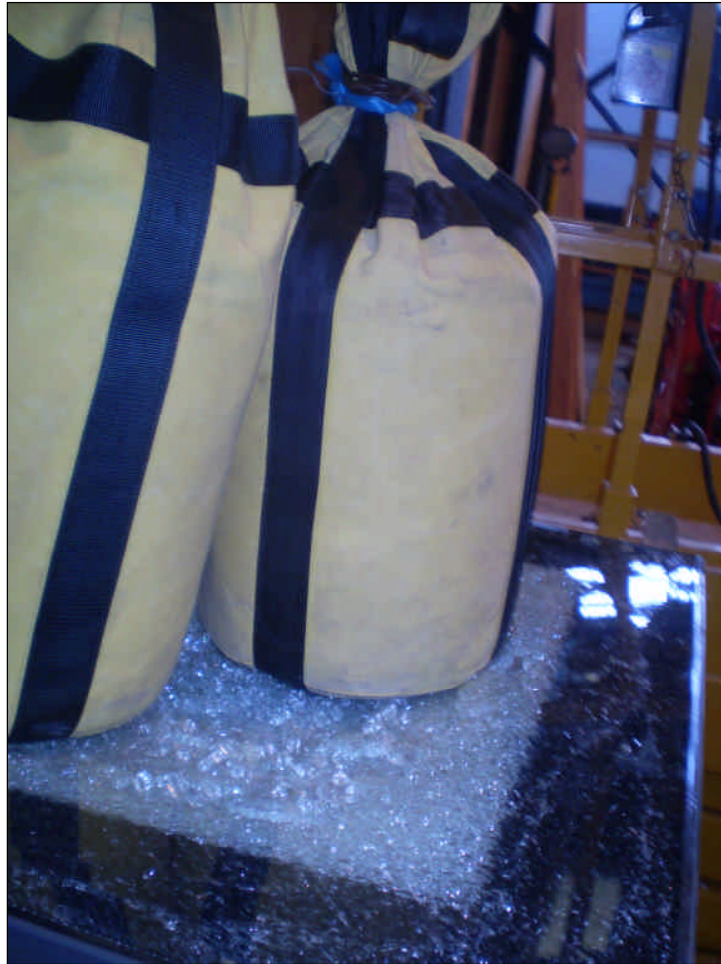
PHOTO 4120061

5.2.6 The 90 kg static load was held for 30 minutes.

5.2.7 Only very small glass fragments were observed on the floor after the test. They were less than 50 mm long and 50 g in weight.

SAMPLE 2 WITH 90 KG STATIC LOAD

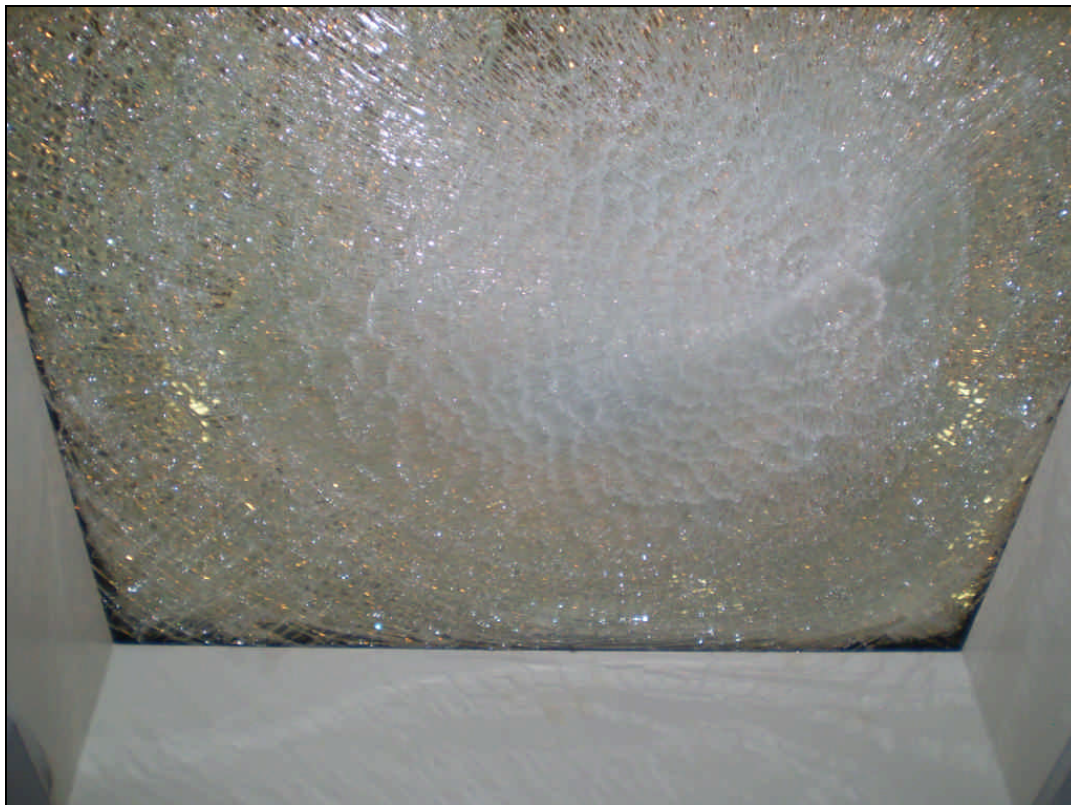
PHOTO 4120063

5.3.6 The glass was observed to sag but the 90 kg static load was held for 30 minutes.

VIEW FROM BENEATH SAMPLE 3 WITH 90 KG STATIC LOAD

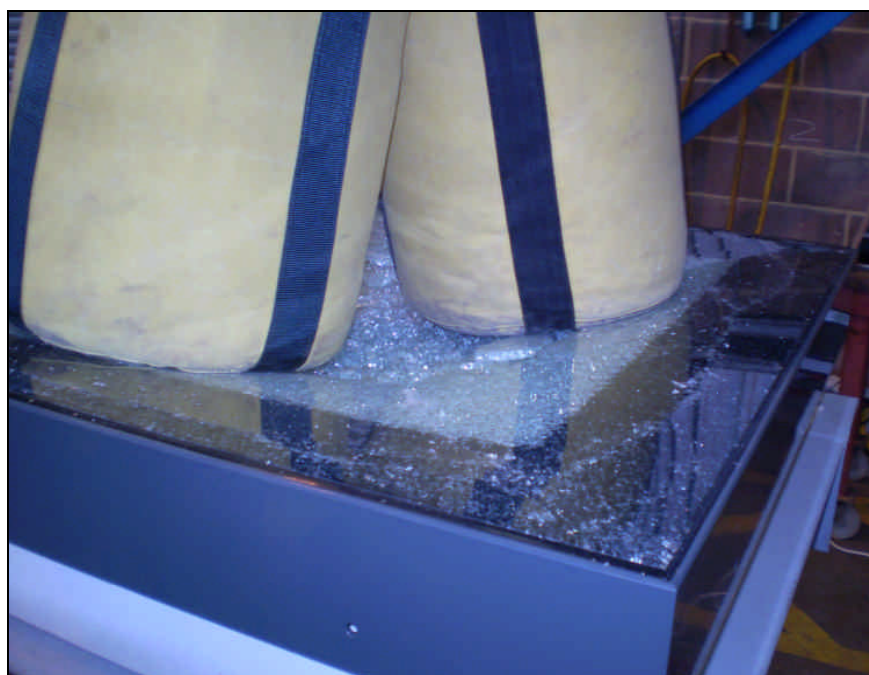
PHOTO 4120064

SAMPLE 3 WITH 90 KG STATIC LOAD

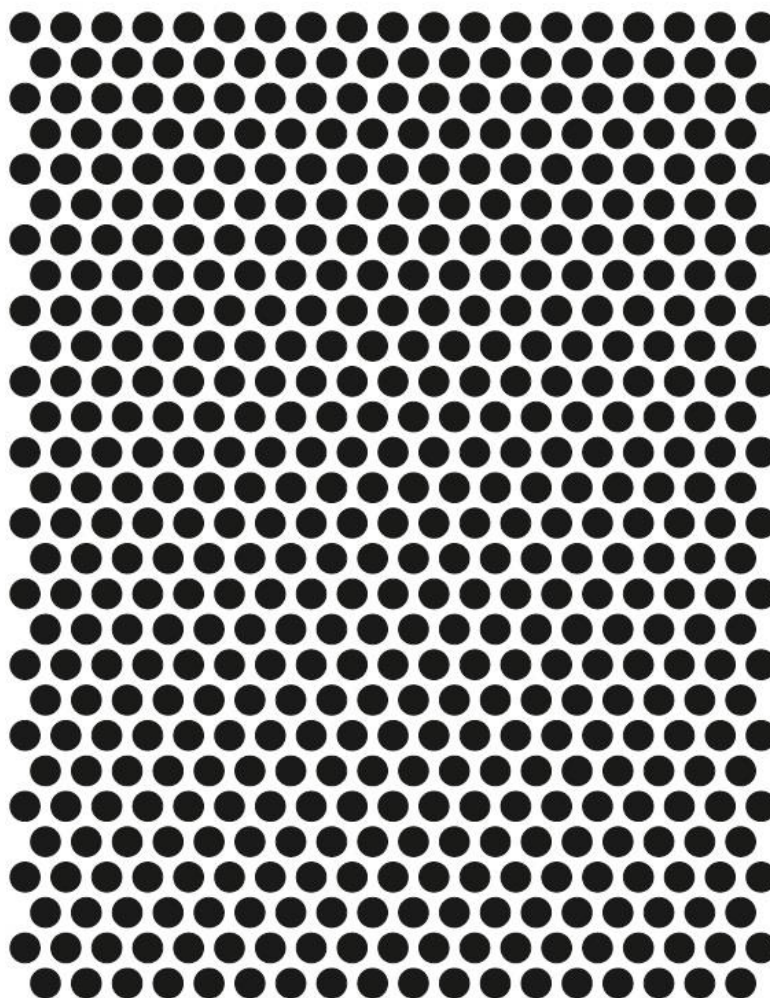
D4; 1,5

Paints: 20/AP/10/40

Silk No.: 24/120

Silk code: D4 : 1.5 <45
